THE DETERIORATION OF GOLD ALLOYS AND SOME ASPECTS OF THEIR CONSERVATION

David A. Scott

Abstract—The different ways in which gold alloys can deteriorate are described. The principal alloys discussed are gold-copper, gold-silver and gold-copper-silver. Examples of South American gold alloys from Colombia and Panama are used to illustrate the different types of corrosive attack. Some problems related to the conservation of gold alloy antiquities are mentioned, together with the difficulty of the preservation of technological evidence.

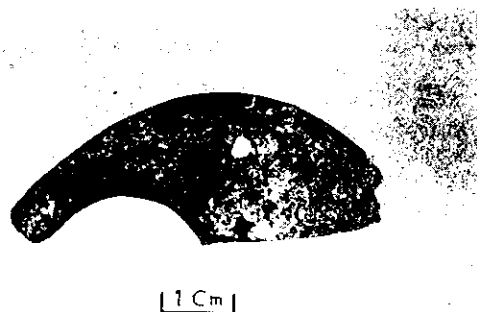
Figure 1 Fragment of a tumbaga alloy from the Nariño area, Colombia, from c. 10th–12th century AD, showing sulphide tarnishing.

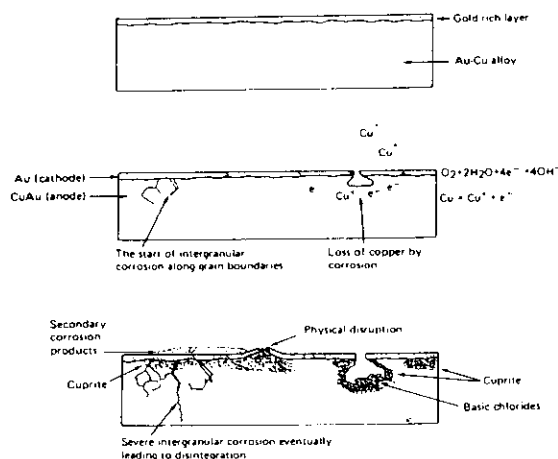
Figure 2 Example of corrosion processes in a depletion gilded gold-copper alloy. The sequence from 1 to 3 illustrates some of the features to be found in the corrosion. With low gold contents, the gilding may eventually detach itself from the heavily mineralized base alloy.

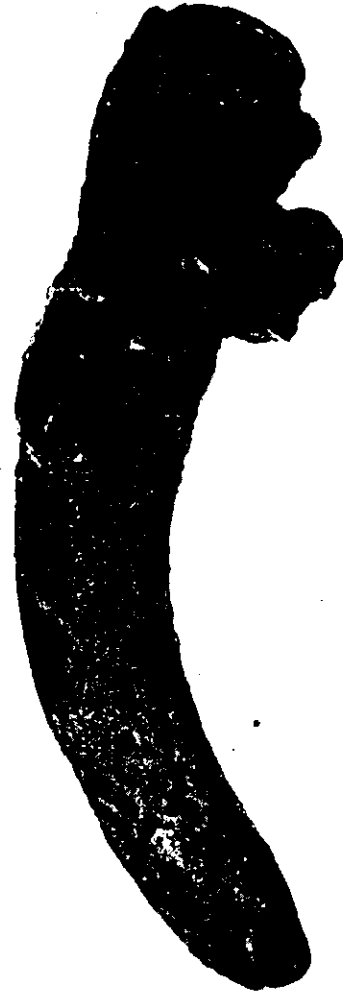
Visual impressions as to the state of a particular object, even when examined under a binocular microscope, may be misleading. An example of such a case is shown in Figure 5. It appears to be a pendant composed of a clay and charcoal core covered with thin gold leaf which is now flaking from the surface. On one or two areas where the gold has been lost, a faint dendritic pattern can be seen on the core. Subsequent examination showed, in fact, that this pendant had been hollow-cast by the lost-wax process over a core which is still *in situ*. Having

established that, it still appears as if the gold alloy used to make the casting is quite thin, as flakes can be detached from the black core. However, it was mentioned previously that heavily corroded tumbaga alloys appear black and powdery in colour. The core materials used in the production of lost-wax castings are also frequently black in colour. There is, therefore, a problem here in deciding what is core material and what is underlying corroded metal.

Figure 5 Coclé style gold pendant from Panama, length 91mm. The pendant is of some interest as it is cast over a core still *in situ* and is made in an alloy of composition 58.2% gold, 35.1% copper, 4.3% silver, which has been finished by depletion gilding. It is now heavily corroded and much of the gold is obscured by copper corrosion products which have also penetrated into the core.

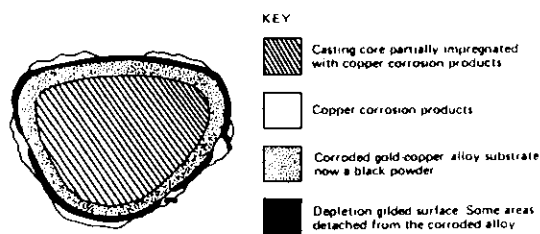
Figure 6 Sketch of a transverse section through the gold pendant shown in Figure 5.

Analysis shows, in fact, that the gold alloy has not been cast as a thin layer, but as a thicker gold-copper alloy, finished by depletion gilding. The boundary between the corroded alloy and the core material is visible in broken sections, but is nonetheless easily confused with the core itself. Copper corrosion products have been partially absorbed by the core and also disfigure much of the depletion-gilded surface. Some surface cleaning of pieces such as this can be attempted with non-ionic detergents in distilled water, applied carefully on swabs to remove encrusted dirt, whilst some of the copper corrosion products can be attacked with reagents such as dilute formic acid. Care must be taken to evaluate the dangers from chemical reagents seeping under the surface of such objects and being absorbed by the core. Gold alloy surfaces obscured by cuprite layers may be particularly difficult to deal with, since most reagents which can be safely used, such as formic acid, will only attack cuprite very slowly. Stronger complexing reagents such as ammonia or the di-sodium salt of EDTA may attack the copper below the surface too vigorously to be safe to use on corroded alloys of this kind.
