# Nautical Archaeology

### On the treatment of pewter plates from the wreck of *La Belle*, 1686

Worth Carlin and Donald H. Keith

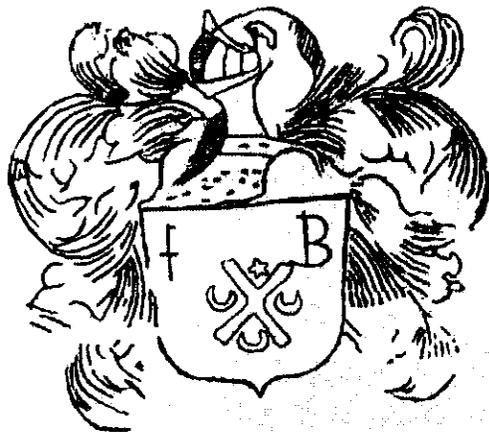
Figure 5. Tracing of the heraldic crest found on six of the plates. (Mary Caruso & D. H. Keith.)

shortly before she was lost. The third mark is the most intriguing (Fig. 5). It appears only on the upper surface of the rims of six plates, four of which were found singly and two of which were nested together in the smaller stack. The mark appears to be an heraldic device composed of an escutcheon containing three crescent moons and a star separated by a cross or X, surmounted by an elaborate winged helm. The escutcheon is stamped or impressed into the plate's surface but the winged helm is engraved. The regularity of the pattern suggests it was made with the help of a template. The plates on which this mark is found are of three different diameters, and the pattern is sized accordingly to fit between each plate's rim and its central depression. As the surfaces of the plates on which this mark appears are invariably in poor condition, portions of the mark are indistinct. The Initials I or P and B are visible in the upper corners of the escutcheon of plate no. 687, and the bottom of an O can be seen on plate no. 776. None of these plates show maker's marks. Perhaps better examples will be discovered on the site in the future.
