# Nautical Archaeology

### On the treatment of pewter plates from the wreck of *La Belle*, 1686

Worth Carlin and Donald H. Keith

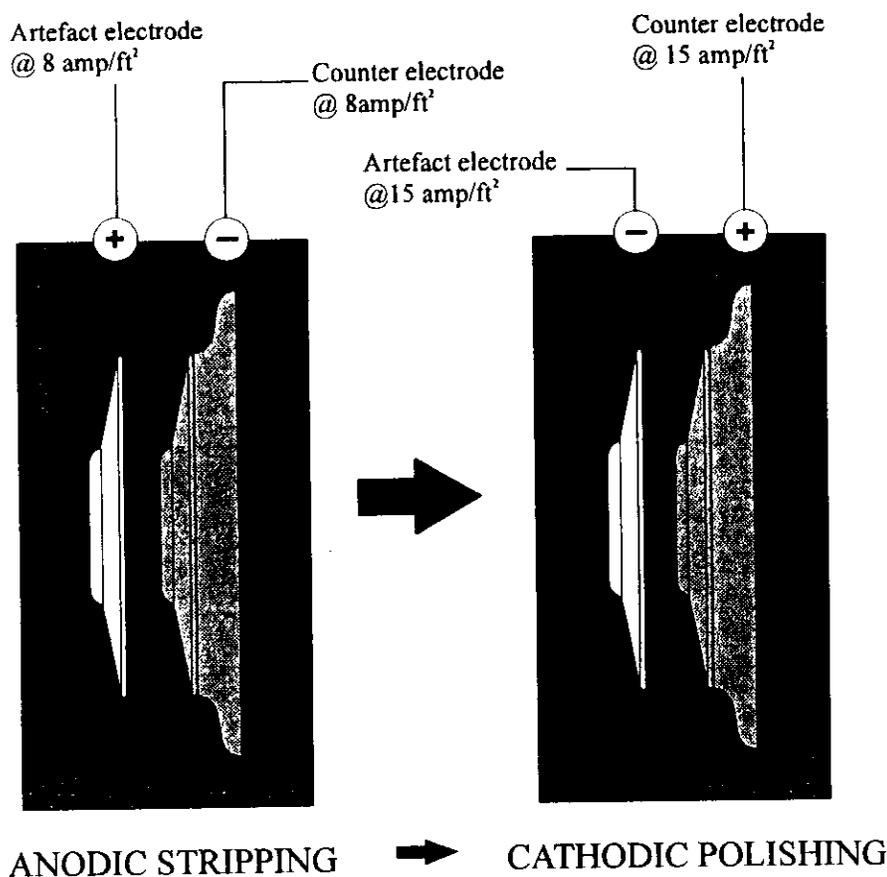
*Figure 7.* Schematic of stripping/polishing electrolytic cell. Stripping the artefact loosens the resistant black film, polishing reduces and brightens the cleaned surface. The plate is turned on edge to avoid trapping gasses released during electrolysis. The counter electrode is shaped to match the contours of the plate. In order to monitor the process more closely, only one side of the plate is treated at a time (D. H. Keith).

8 amp/ft<sup>2</sup> (0.006–0.009 amp/cm<sup>2</sup>) in an electrolyte of 2.5% sulphuric acid for very brief intervals after which the plate was removed and inspected to determine/monitor the changes taking place (Fig. 7). Although the initial treatments were limited to 15-min intervals before inspection, electrolysis periods were extended as confidence in the technique grew, and on average all plates were anodized for 2 h. Anodization did not effect complete removal of the corrosion products but rather changed the character of the film. At this point the current was reversed so that the plate was cathodic and the current density was increased to 15 amp/ft<sup>2</sup> (0.016 amp/cm<sup>2</sup>). The effectiveness of this anodic stripping-cathodic polishing procedure can be observed in the photograph of a pewter plate in which only half of the plate was treated in this manner (Fig. 8).
